HIGH PERFORMANCE MAGAZINE CERTIFICATION TEST NO. 3: PLANNING AND RESULTS

Robert N. Murtha
Naval Facilities Engineering Service Center, Port Hueneme, CA

28th DDESB Seminar
Omni Rosen Hotel
Orlando, FL
18-20 August 1998

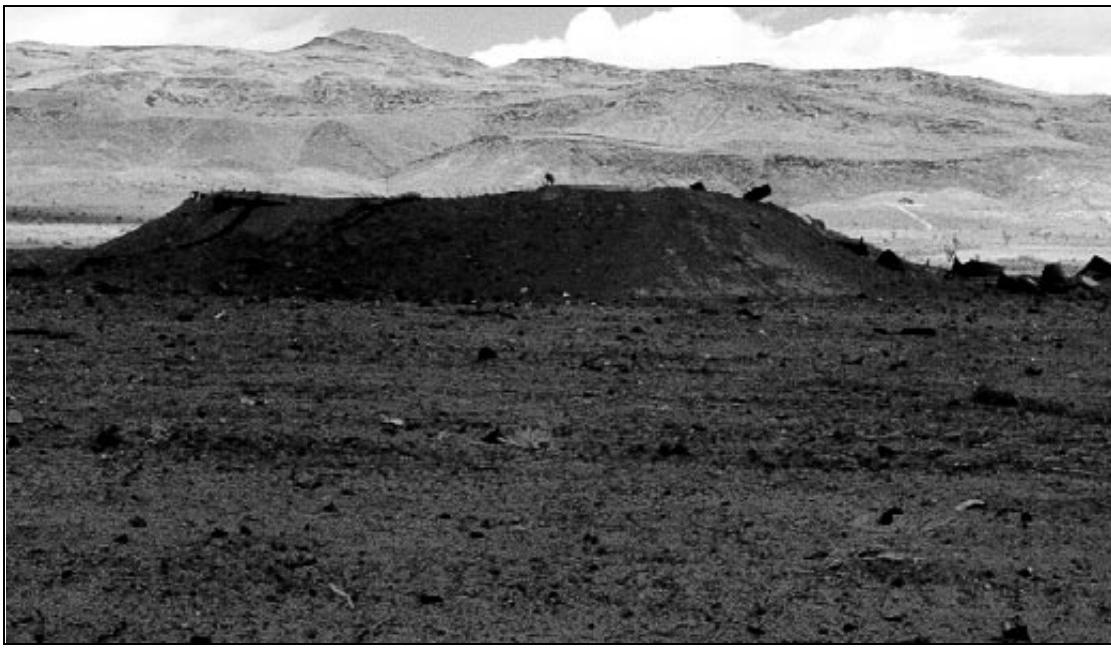
Photographs taken the next day of the exterior CT3 site are shown in Figure 19. None of the 2nd story structure remained. Closer views of the interior damage to the CT3 structure are shown in Figures 20, 21, and 22. The exterior concrete walls of Cell D3 were destroyed and small pieces of concrete were thrown outside the structure. The exterior walls of the SRA and the three acceptor cells were rotated outward against the soil berm. The following internal nonpropagation walls were destroyed and completely missing:

- SRA transfer aisle wall between D1 and Cells A1/A2
- Cell wall between D3 and Cell A1
- Storage transfer aisle wall between D3 and Cell A3

The storage transfer aisle wall between Cells A1 and A2, where donor D2 was located, was crushed downward and broken.

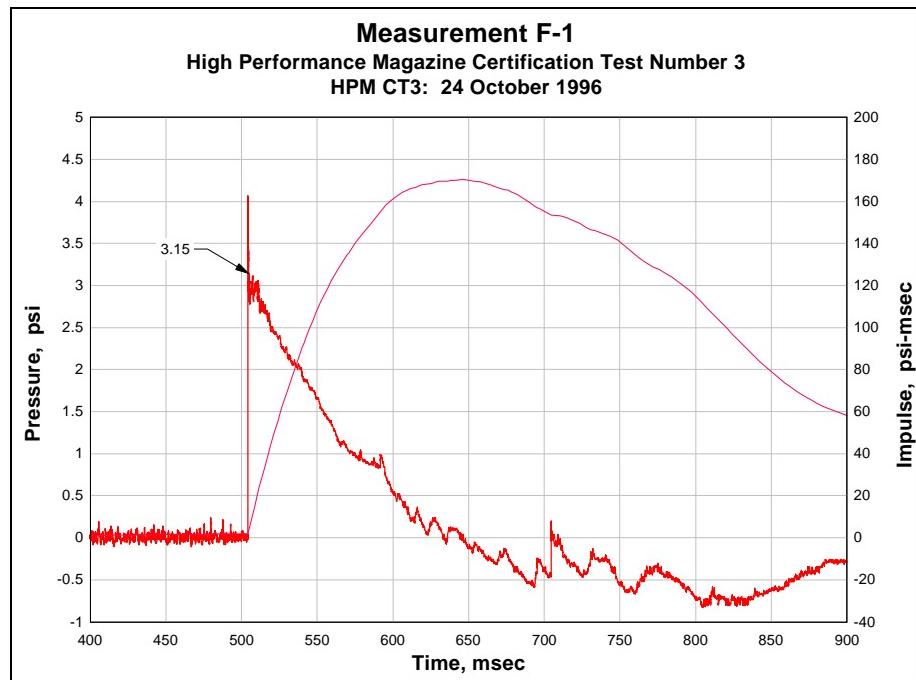
Figure 23. External airblast pressure measurement F-1.

Reference 7 contains the digitized external pressure data recorded at the test site altitude of 5,000' above sea level. Impulses were obtained by numerically integrating the data. A 9500 Hz low-pass filter was applied to the pressure data. The data are referenced to a common zero time (Time of Detonation) and are displayed with time in milliseconds on the abscissa and the data output on the ordinate. A typical data record is shown in Figure 23.

The values of the measured peak pressures at altitude are listed in Table 2. These peaks are not the initial spikes seen on some of the waveforms, which is an overshoot associated with quick rise times for this type of gage, but rather interpretations of the actual peaks based on the intersection of an exponential curve drawn through the waveform and the vertical rise at the waveform arrival. However, in order to compare this data with the results from analytical prediction models, the data was converted to sea level conditions using a computational procedure outlined in Reference 7. These adjusted measured peak pressures and their ranges are listed in Table 3.

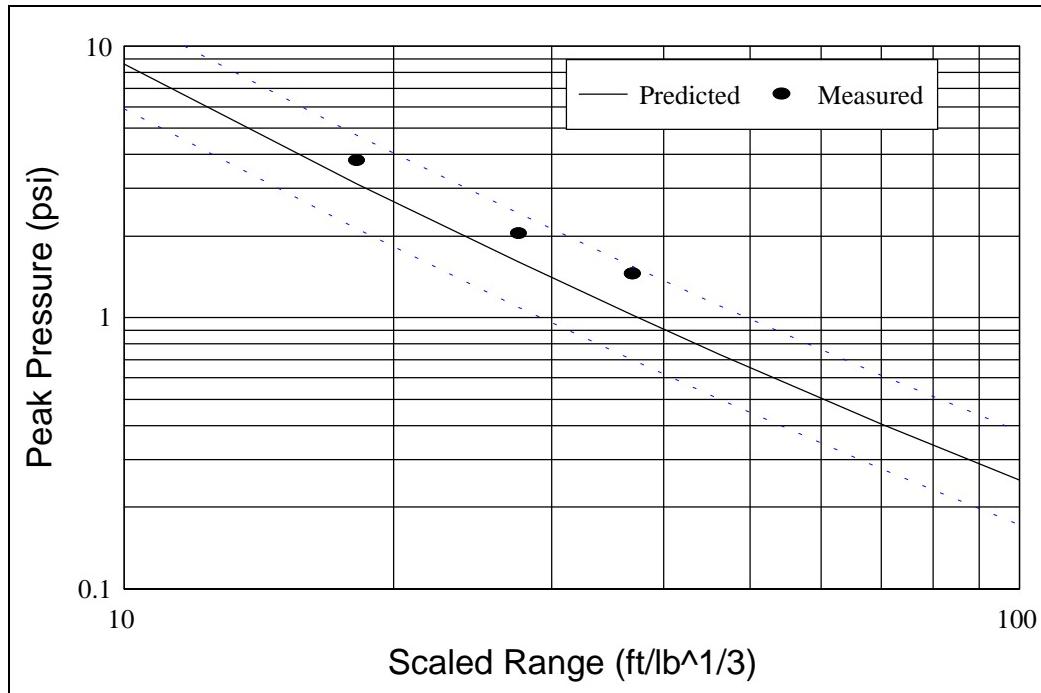
Figure 24. Measured vs. predicted peak external pressures: Front.

In both of these two directions, the safe inhabited building distance, IBD, was established as $35W^{1/3}$ for earth-covered magazines. Because the HPM does not have the unbermed frontwall of an earth-covered magazine, the measured peak pressures to the back of the HPM will be compared to the earth-covered magazine equation for the side direction. The predicted peak pressures based on these earth-covered magazine tests are listed in Table 3 for all the pressure gage stations at sea level conditions. These predictions are plotted versus scaled range as single solid lines in Figures 24 and 25. The measured external peak pressures listed in Table 3 are also plotted in these figures, and are within the lower and upper bounds (see dashed lines) of the data scatter for these best-fit equations. Thus, the safe IBD for the HPM is also established as $35W^{1/3}$.

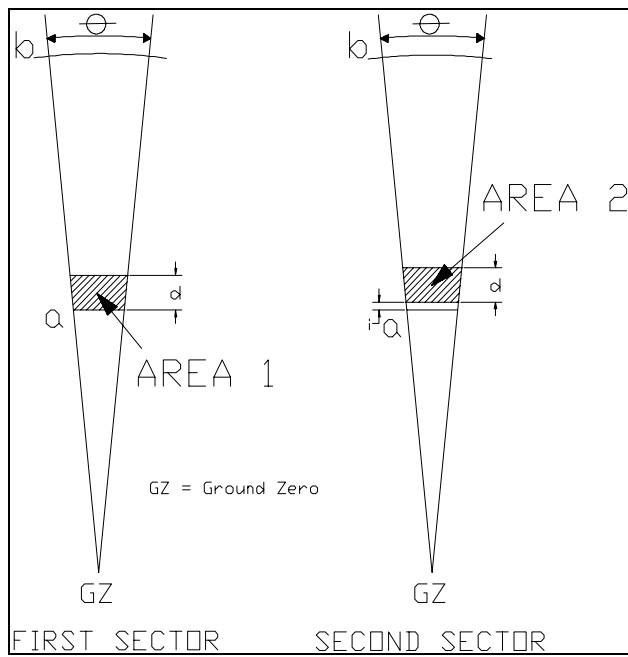
Figure 27. Schematic representation of Jacobs' Method.

The U.S. DOD and Navy Explosives Safety Standards (References 8 & 9) criterion for debris hazard range is the farthest distance to a debris density of one hazardous particle per 600 ft^2 . All the debris recovered within the three 10° sectors are considered lethal and hazardous. The technique proposed by Jacobs is used for analysis and interpretation of the hazardous debris density. The Jacob's method is illustrated in Figure 27. According to the Jacob's method, a sector of the annulus of length " d " (100' in this analysis) was moved away from ground zero (GZ) in increments of " i " (20' in this analysis). The analysis was started at distance " a ", representing the inner border in the closed-in region where 100% debris recovery was initiated. For each increment, the area of the sector was calculated, the number of debris in the sector was counted, and the number of debris per 600 ft^2 was determined. This process was continued until the farthest debris (distance " b ") was included in the debris-distance calculations. The distance from GZ to the center of the sector of the annulus is the distance reported for the hazardous debris density. An example of the debris areal distributions for CT3, as collected in the front sector, is listed in Table 4. The debris densities for all three directions are graphically shown in Figures 28, 29, and 30. In order to determine the quantity-distance (Q-D) a curve fitting technique based on an exponential function with a generalized form given by:

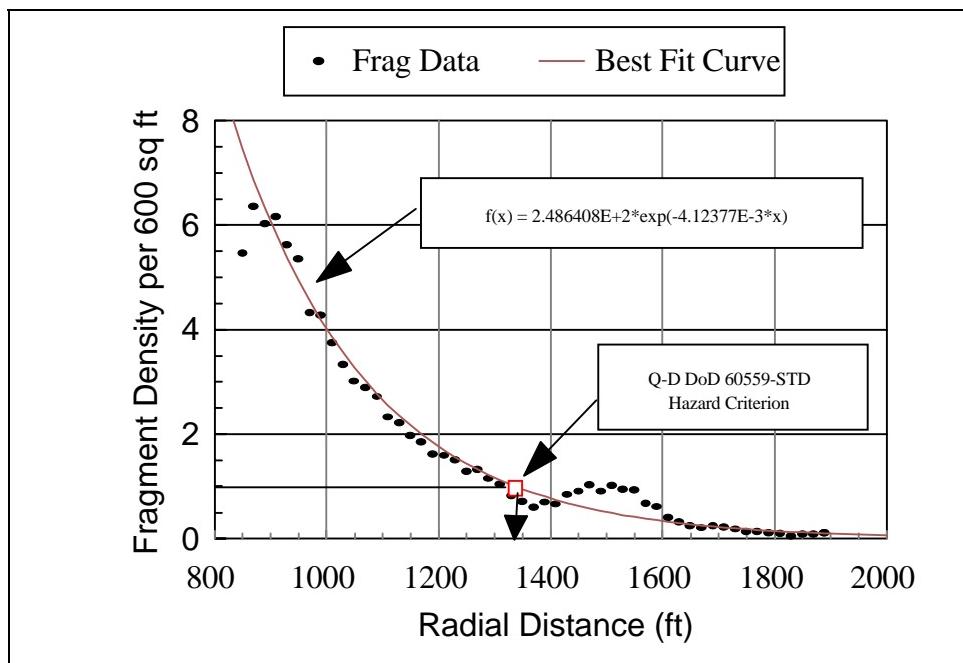
Figure 28. Debris areal number density distribution: Front sector.

was used. For such statistical analysis, values of constants are calculated so that the sum of the square of the errors given by $[g(x_i) - \ln(y_i)]^2$ is minimized. The statistical fit for each set of data from the three sectors are shown by the inserted equation $f(x)$ in Figures 28, 29, and 30. From these equations, the Q-D values defining the hazard criterion in the three debris recovery sectors were

- Front Sector (0°): D = 1,337.6'
- Side Sector (90°): D = 1,108.3'
- Back Sector (180°): D = 1,145.0'

These distances are less than the distances determined for any other experimentally tested earth-covered magazine. Thus, the previously established safe debris distance of 1250' for earth-covered magazines can also be used for the HPM.
